Summary of OS preparations

Deliverable 34.1

eUropean naturalistic Driving and Riding for Infrastructure and Vehicle safety and Environment

Deliverable No.	UDRIVE D34.1	
Deliverable Title	Summary of OS operations	
Dissemination level	Public	
Written By	Julie Castermans (ERTICO – ITS Europe) Karla Quintero (CEESAR) Ruth Welsh (LOUGHBOROUGH University) Maartje de Goede (TNO) Mohamed Mahmod (DLR) Oscar Martin Perez (CIDAUT) Jakub Zawieska (IBDiM)	09-05-2017
Checked by	Anne Guillaume (LAB)	17-05-2017
Approved by	Marika Hoedemaeker (TNO) QA manager Nicole van Nes (SWOV) Project Coördinator	30-06-2017 30-06-2017
Status	Final	30-06-2017

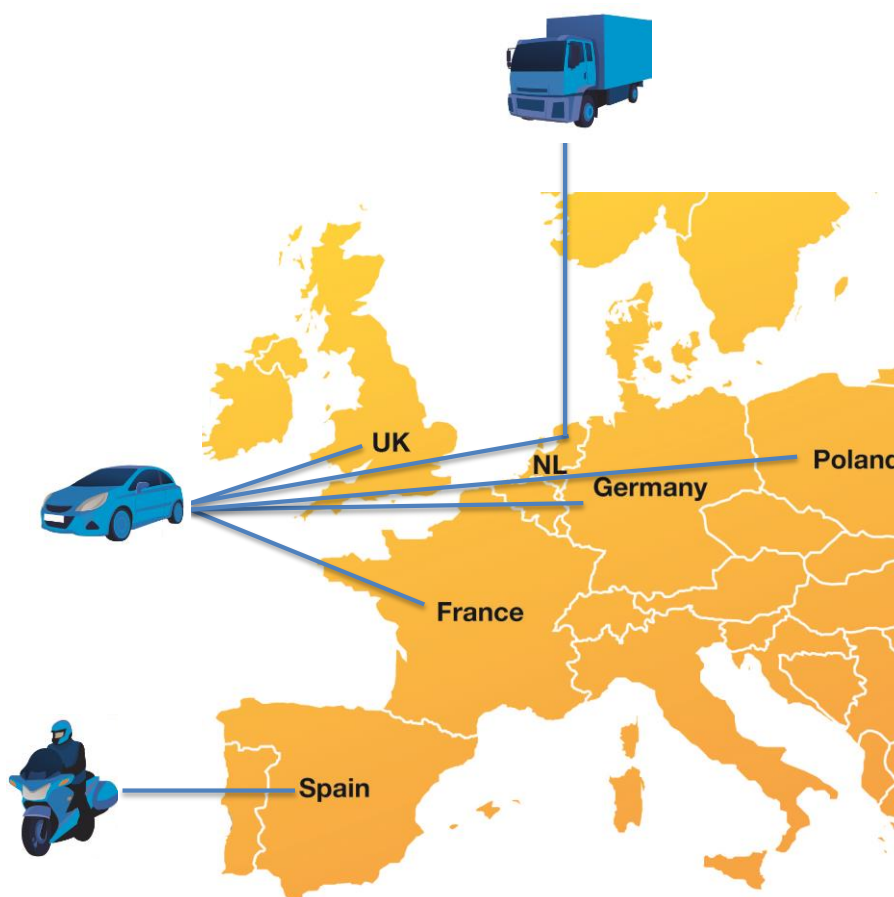
Figure 1: UDRIVE Operation sites and vehicle types

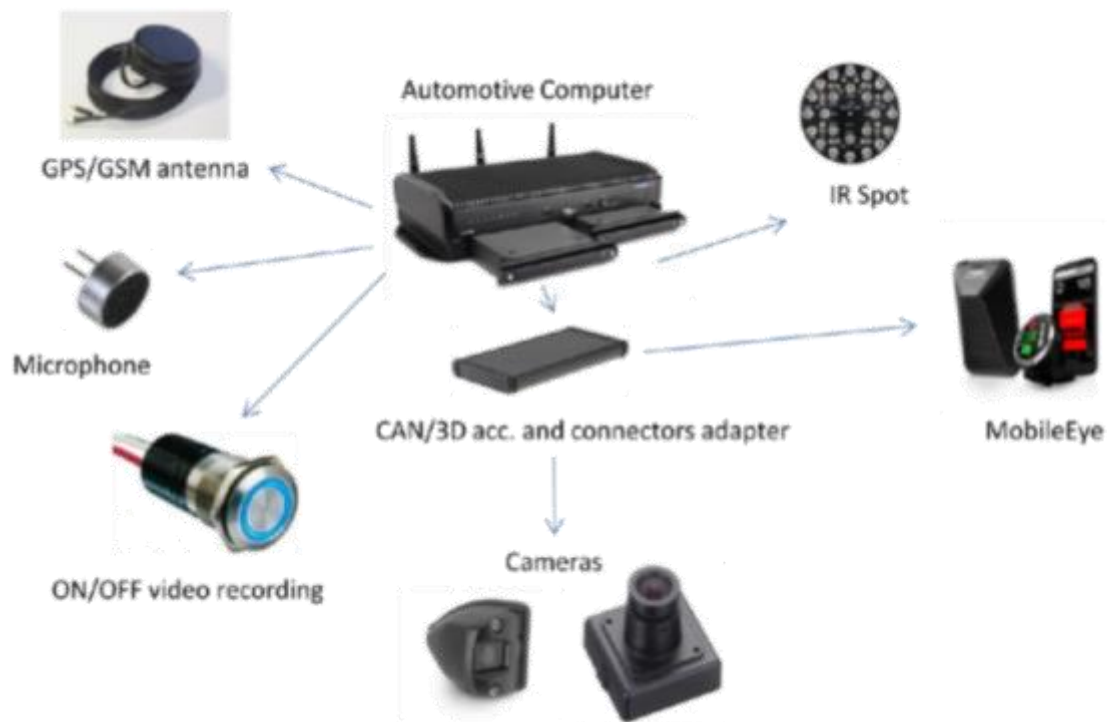
The data acquisition system was developed in UDRIVE by SP2 and manufactured by Sectronic. The Data Acquisition System (DAS) consists of various elements including data logger, cameras (including a MobileEye smart camera, though not for PTWs, and an additional blind spot camera for trucks only), speed sensor (only for PTW), OBD connector, GPS antenna and wiring.

Figure 4: Equipment to install

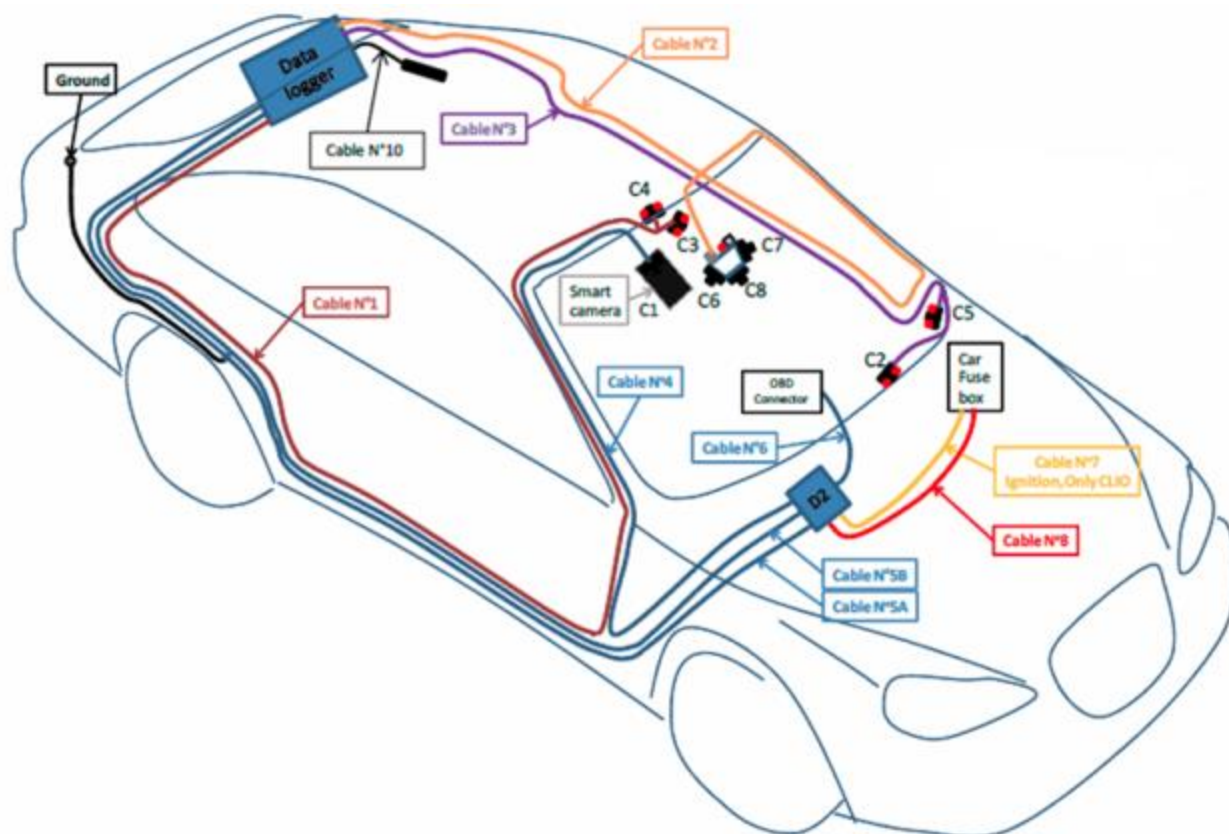
Figure 5: Car installation diagram

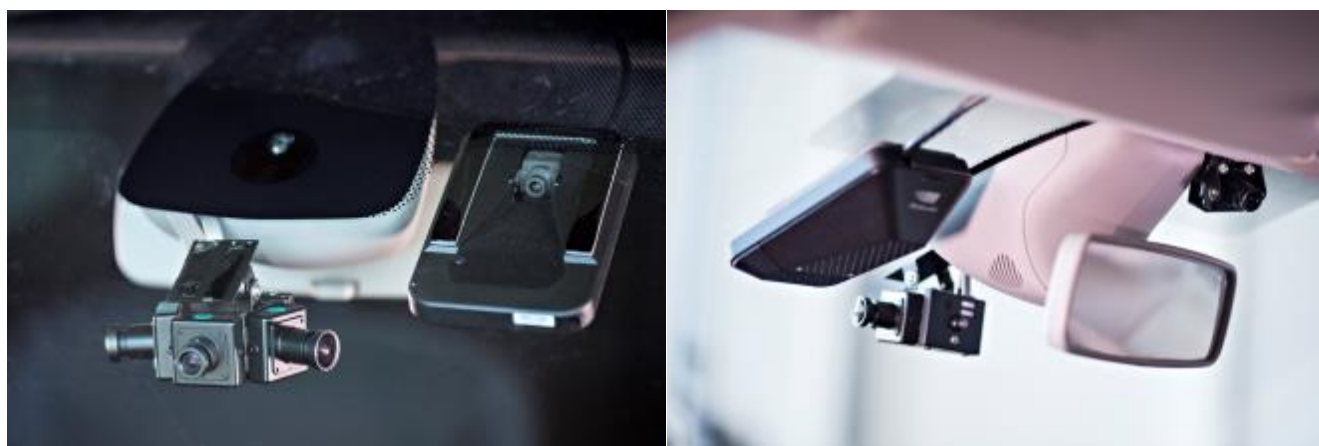
The MobileEye was mounted onto the windscreen, next to the rear view mirror. Three cameras built together in one unit were mounted behind the rear view mirror and looked forwards and peripherally to the left and right of the vehicle. The passenger compartment camera, pointing inwards to capture the presence of passengers in the vehicle, was mounted on the other side of the rear view mirror.

Figure 6 and Figure 7: Forward cameras and MobileEye (left) as well as driver compartment camera (right) in a UK car installation

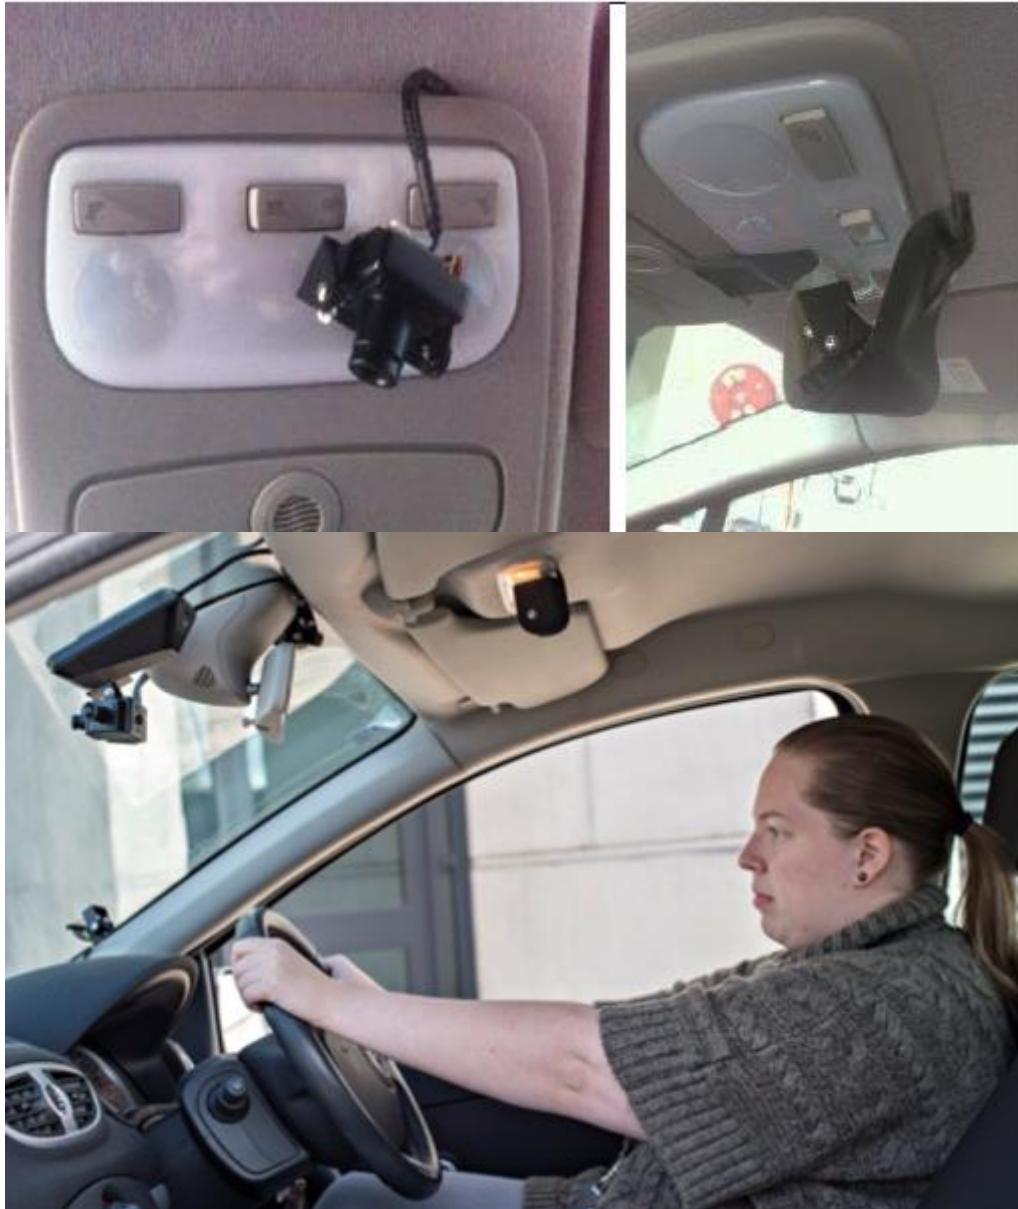
The driver action camera (recording the interaction with vehicle controls) was fixed on the ceiling interior light, the driver's face camera, along the left windshield pillar, and the footwell or feet camera, above the pedals by way of a pedal board cover.

Figure 8 and Figure 9: Ceiling camera and cover protection clipped onto it after setting as well as driver face camera along windshield pillar in a UK car installation

A recurring problem concerned the driver action camera that was attached to the interior light housing. Warm weather and the heat of the interior light caused this camera to fall loose for many participants and regular visits were required in order to re-fix the camera and check the camera settings.

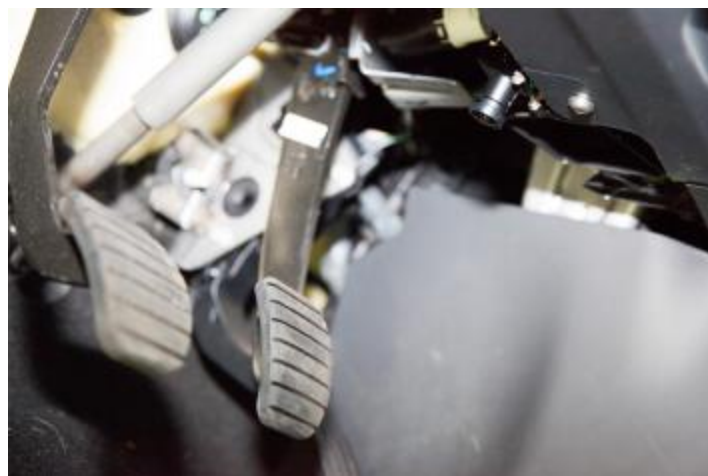
Figure 10: Feet camera

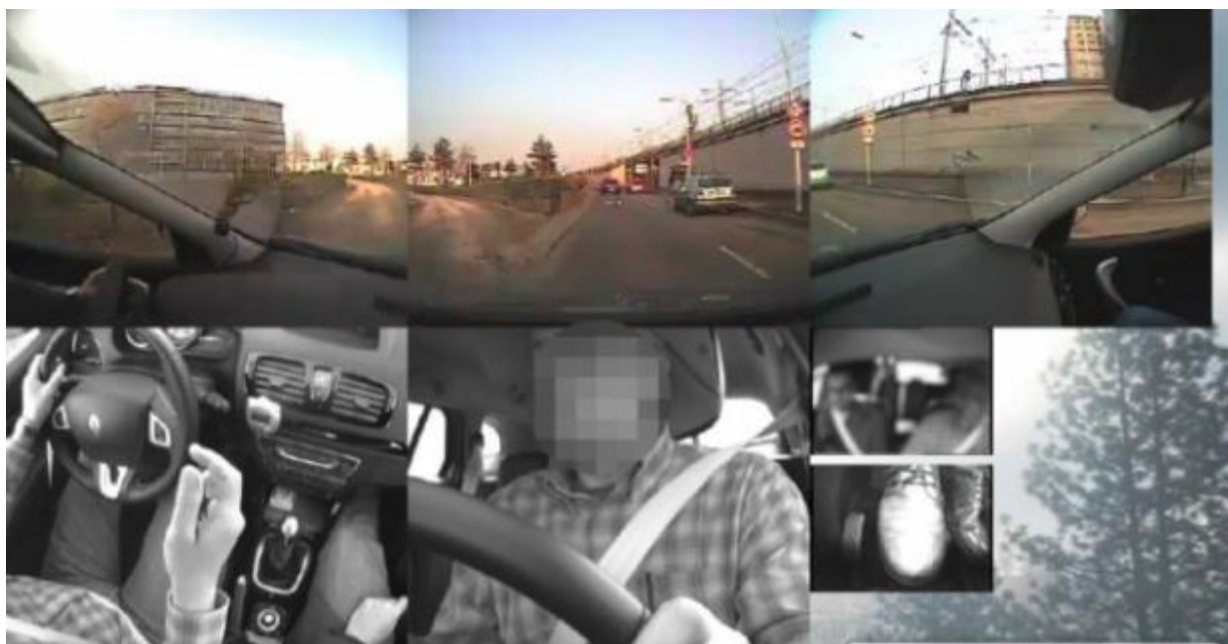
Figure 11: Views from all car cameras

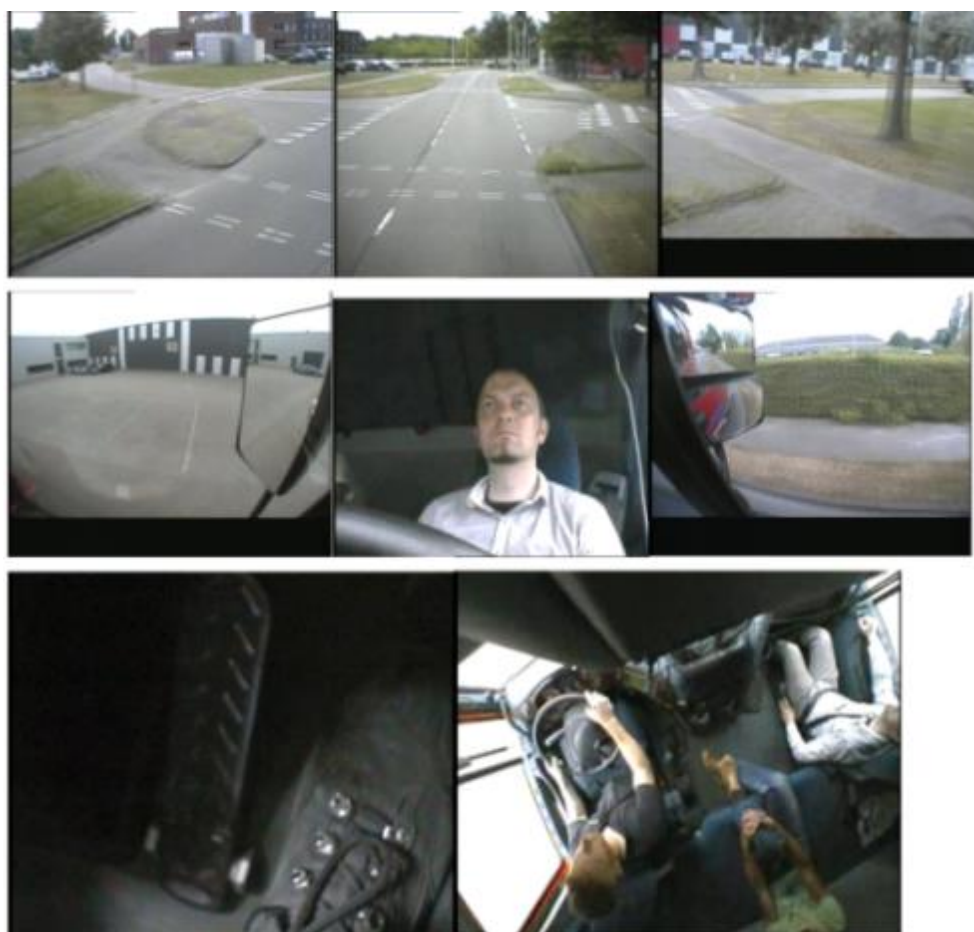
Trucks were also equipped with two additional blind spot cameras and an external gyro (internal for cars). The left and right blind spot cameras were mounted (on a bracket) between the roof lining and the curtain rail. The gyro was mounted behind the dashboard where the gearstick used to be mounted for trucks with manual gearbox.

Figure 12: Views from all truck cameras

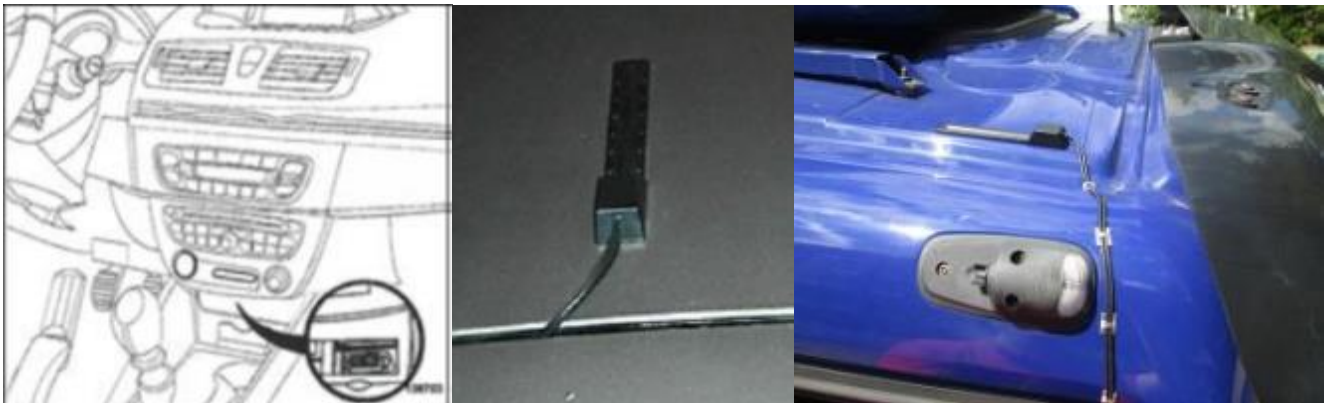
The car OBD connector was placed in front of the gearshift and the GPS antenna was mounted on the roof.

Figure 13, Figure 14 and Figure 15: OBD connector and GPS antenna

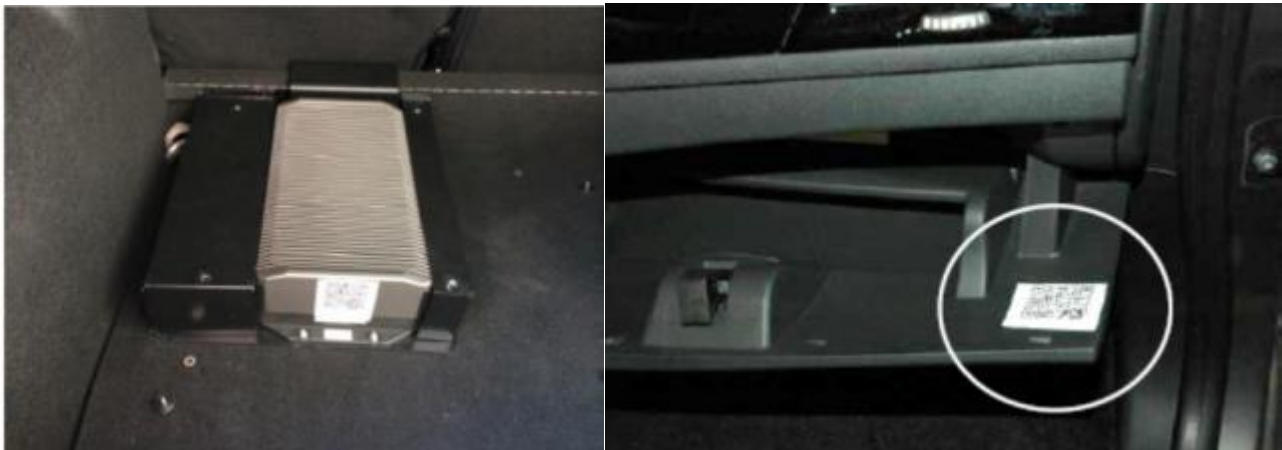
The data logger (DAS) was placed in the boot for cars, in the top case for PTWs and in the overhead compartment for trucks. The DAS had been pre-configured on the bench to make sure that the SIM card was working, passwords were set and that the firmware was flashed through the CF card. The DAS installation involved scanning the QR code of the vehicle, which was fixed in the glove box, before scanning the QR code of the DAS, with a smartphone, in order to complete the registration onto the OMT. The first hard drive disk was also scanned so as to be “attached” to that particular DAS on the OMT.

Figure 16 and Figure 17: Data logger and vehicle QR code

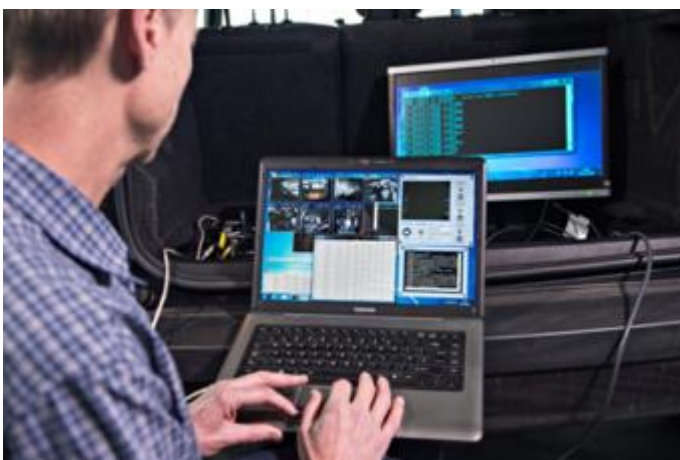
Figure 18: Installer calibrating and verifying all parameters

The installer then had to calibrate the MobileEye and configure the cameras following the instructions from the camera settings guide. With help of a laptop and Local Area Network connection with the DAS, installers could access the DAS and put it into installation mode in order to run the software used to configure the cameras. Installers checked that the data logger was on and that they were getting video data streams from the cameras. Installers would then position and set correctly the cameras, adjust the focus of the image and fix the cameras definitively.

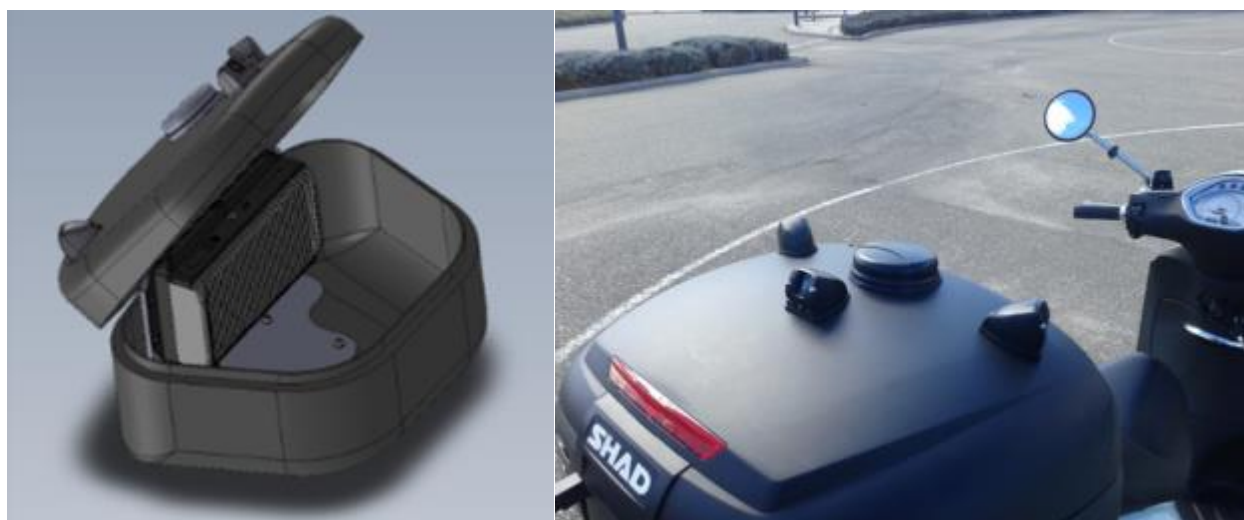
No CAN connection was applicable either for PTWs. The DAS was mounted inside the top-case, as well as a spare battery. Three cameras, pointing backwards and peripherally to the left and right of the vehicle, as well as the GPS antenna were fixed onto the top-case.

Figure 19 and Figure 20: Topcase for PTWs, showing the DAS, 3 cameras and GPS antenna

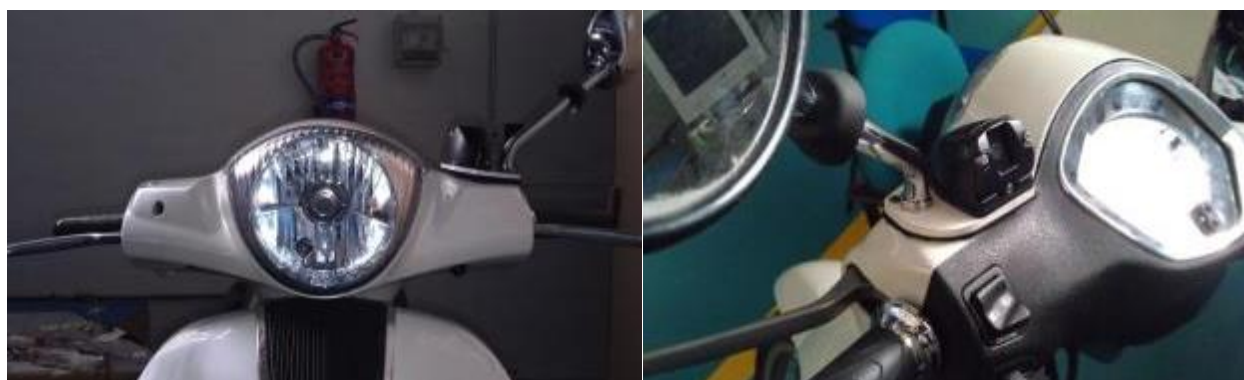
The driver face camera was fixed on the dashboard and the forward camera next to the rear view mirror.

Figure 21 and Figure 22: PTW forward (left) and driver face (right) cameras

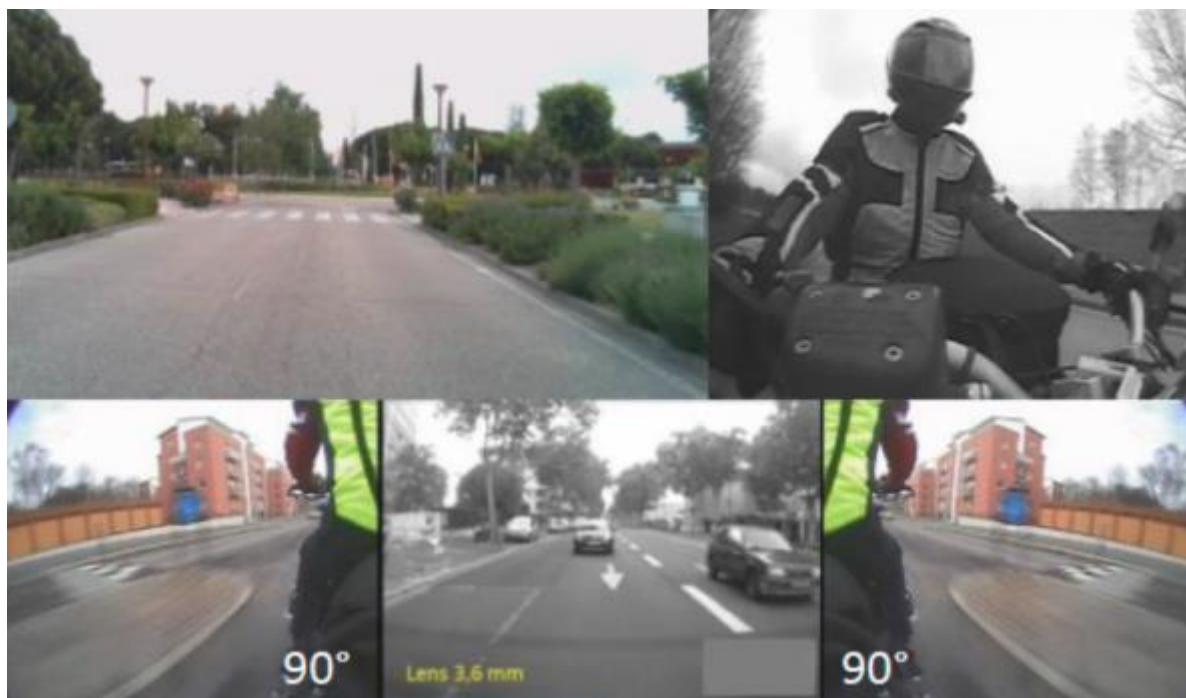
Figure 23: Views from the 5 PTW cameras

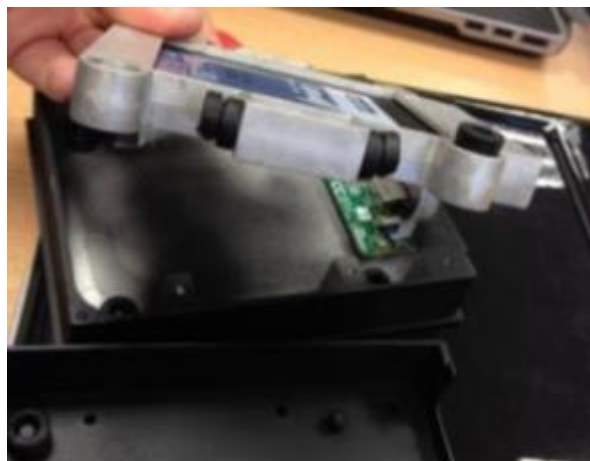
Data is stored on a hard disc drive (HDD) or solid state drive (SSD)¹⁴ in each vehicle and encrypted to ensure privacy in the event of theft. The disks were changed by OS team members on average every two to three months, or when a hard drive disk (HDD) was getting full.

Figure 24: DAS Hard drive protection system, relevant for change of hard drive

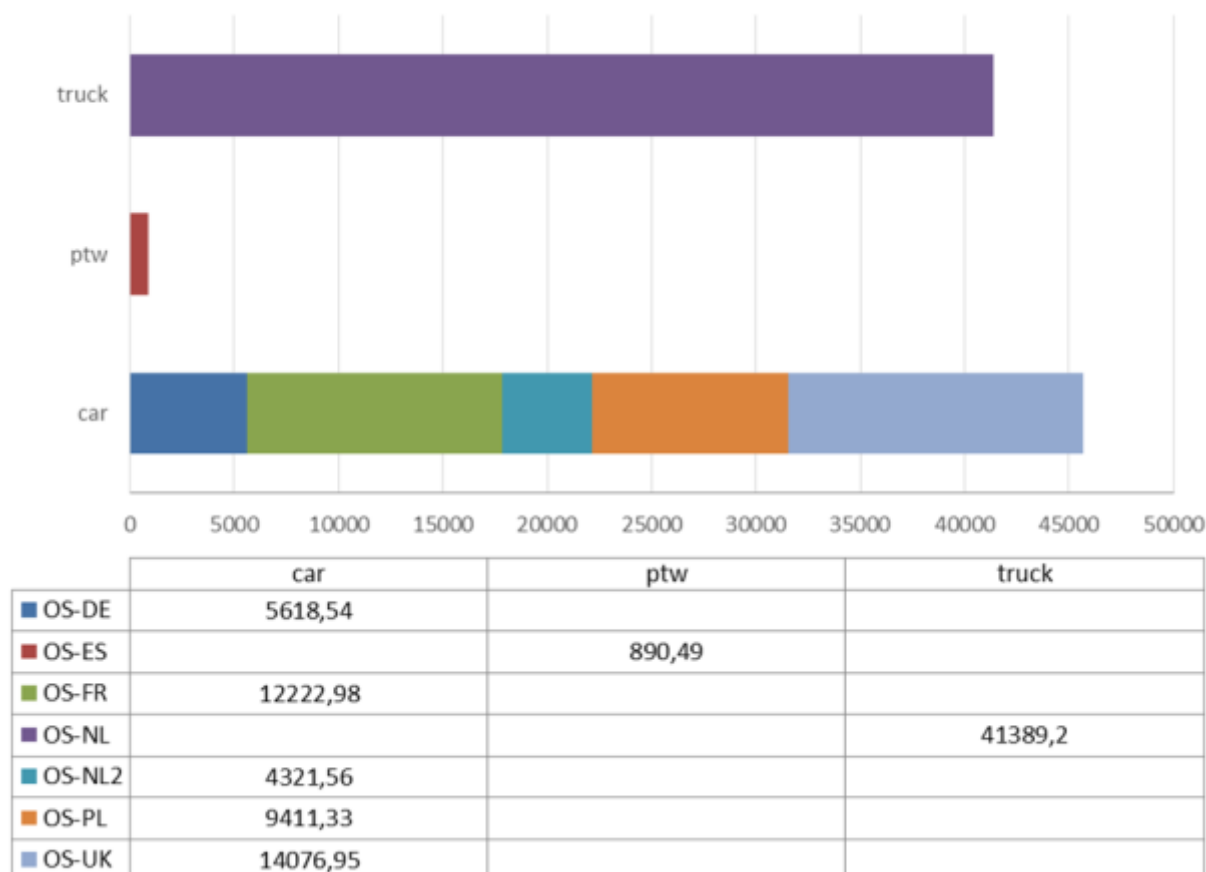
Figure 25: Figures of data collected per OS and vehicle type (in hours)

Considering the number of vehicles, the biggest data collector across vehicle types is understandably the truck OS seeing that they are driving for their commercial activity. However this is also where the percentage of data actually available for analysis is the lowest after driver ID-ing. As it seems unrealistic to ask fleet managers to allocate equipped trucks to participating drivers only, efforts should be focused on convincing all drivers allocated to equipped trucks to sign in as participants or on briefing them regularly about the study and the switch off button to avoid being recorded. Involving Unions from the beginning is also a must due to their strong influence on drivers.

Among car OSs, UK and France were the biggest collectors, followed by the Dutch Lease OS (considering that they only had 10 vehicles). For the first two, the fact that they didn't experience any major issue with the equipment can be an explanation. Nor did the Dutch car OS, which moreover recruited lease drivers, who use the car primarily for the professional activity.

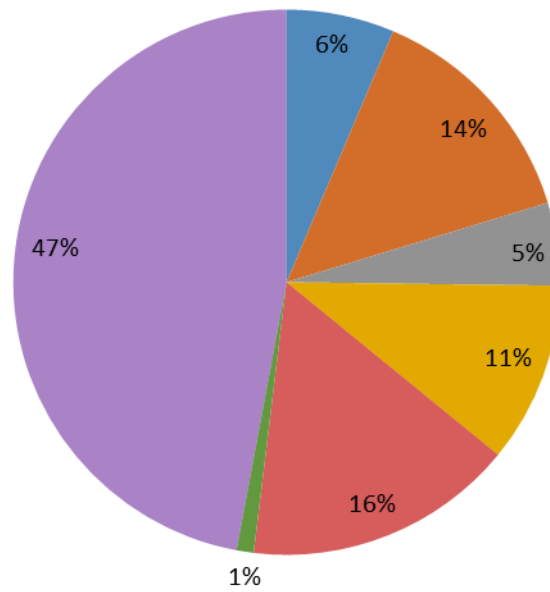
Figure 26: Proportion of data collected per OS

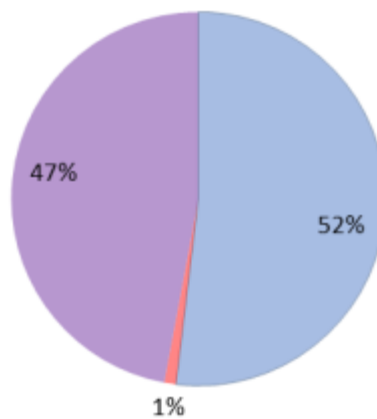
Figure 27: Proportion of data collected per vehicle type
